Passing the Erosion Test

EroSolve solves wet steam erosion problem at Indian power plant

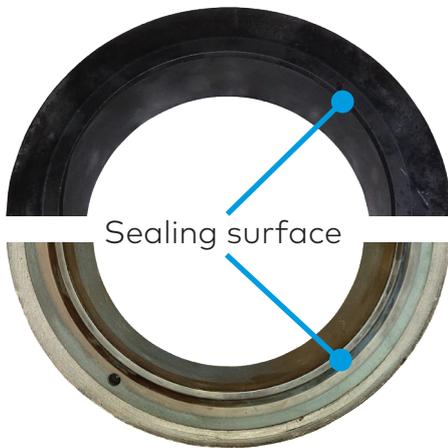
Having originally supplied the Sulzer® technology HP valves about five years previously, IMI CCI engineers visited the plant in July 2019 to review the installation and piping. They discovered that, during start-ups, instead of dry saturated steam, wet steam was flowing through the valve during start-ups due to insufficient drainage in the pipeline. Flashing condensate/ wet steam is highly erosive when it passes over the trim parts at high velocity and a high angle of impingement. However, the customer ruled out adding drains to the piping on cost grounds.

Original seat (top) vs EroSolve seat

The IMI CCI team suggested replacing the trim with the EroSolve solution. This is designed to delay erosion and extend the life of valves in precisely these types of wet steam/condensate operating conditions.

the EroSolve trim has successfully completed five cold start-ups, whilst the earlier trim was eroding after two to three cold start-ups.

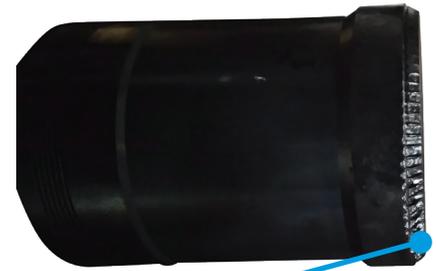
The trim upgrade was installed in January 2020. When the valve was opened after a year of operation, both the plug and seat ring sealing surfaces were intact and there were no indications of erosion or damage. The team carried out a dye penetrant test which showed the sealing surfaces to be in perfect condition. To date,

Sealing surface

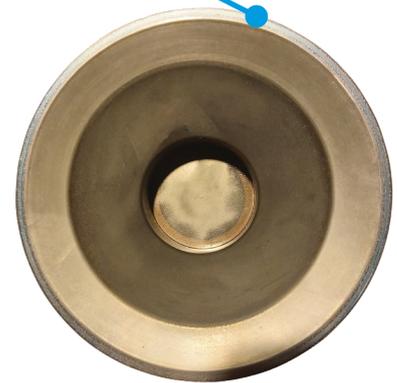
Original plug erosion (top) vs EroSolve plug still intact
