# CCPP installs EroSolve trim to prevent erosion from flashing

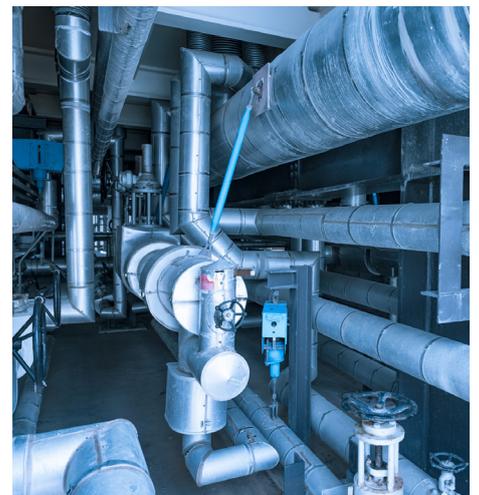
A South Korean CCPP began to experience erosion due to flashing in four blowdown valves in the plant's heat recovery steam generators after the plant had been operating for just two years. The degree of erosion meant the client was experiencing erosion to the seat and disk stack as well as the outlet piping.

IMI Critical Engineering carried out a root cause analysis to determine the operating conditions in the plant. This revealed a water-steam mix of over 45%, which was causing severe flashing and erosion of the angle-type 100D valves used in the application. The damage was concentrated in the plug-seat contact area and the end of the seat sleeve, with additional damage to piping connected to the valve outlet.

The IMI Critical Engineering team proposed replacing the 100D DRAG® valves with its 860G-ESF bare stem valve with flashing trim. This included a special plug and seat design to move the flashing point away from the plug and seat. In addition, the new plug and seat were manufactured in 440C stainless steel, a very hard steel alloy that is resistant to erosion. The valve body was also upgraded to a more resistant material, SA217 WC9, and periodic inspections were recommended to ensure the valve remained in good operating condition.
