How the Metamorphic Trim Reduced OPEX and Improved Water Quality for an Offshore Platform

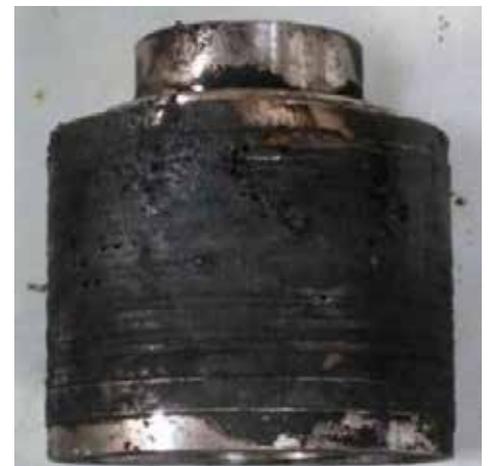
A major Oil & Gas producer in Norway was suffering from clogged valves in the hydrocarbon separation unit on an offshore platform. The three valves that were clogging were installed at the hydrocyclone letdown, with one valve for each separator, and needed to handle high differential pressures and low flow rates, as well as particle contaminated sticky fluid.

Due to improvements to the Enhanced Oil Recovery (EOR) system, the field life was extended beyond the original planned life of the wells. This introduced new challenges and resulted in the original valve being no longer fit for service. During late well life, it is typical for the amount of produced sand and slurries to increase, which occurred in this case. As a result, the original installed multi-stage valve trims clogged repeatedly. This caused reduced efficiency of the produced water treatment system. Frequent maintenance was also required to manually open and clean the valve every two-three months of operation.

The original multistage valve trim clogged by sand and sticky fluid.

IMI Critical Engineering introduced the customer to the new EroSolve Metamorphic Trim (MMT) product, the world's first self-cleaning Metamorphic valve Trim, combining the benefits of multistage-labyrinth and cascade technologies.

Our solution met the customer's needs by preventing the particle contaminated sticky fluid from clogging the valve and being able to handle the high pressure drop as well as small flow rates. The customer strongly believed in our new technology, even though there was no installed base or field proven reference at the time of quotation.

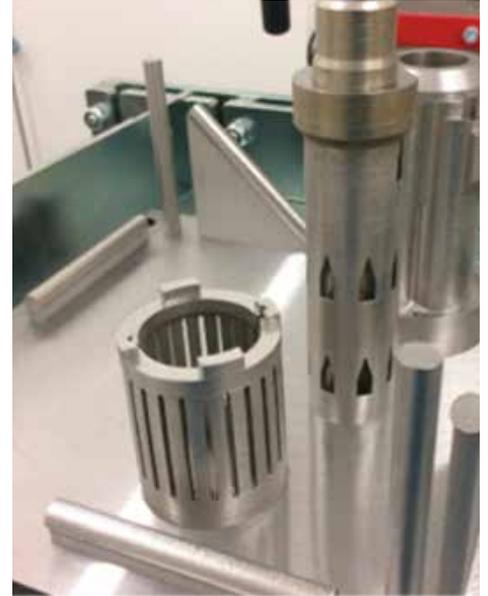
Complete EroSolve MMT upgrade components for offshore.

To minimise critical downtime during the valve upgrade, the new trim was installed by an IMI CCI field service engineer onsite, offshore. The trim was retrofitted into the existing valve body without removing the valve from the line. This ensured a fast installation, but also minimised waste and scrapped parts by reusing existing major valve parts such as the body and actuator.
