Case Study

Oil production company seeks solution to vibration control problems

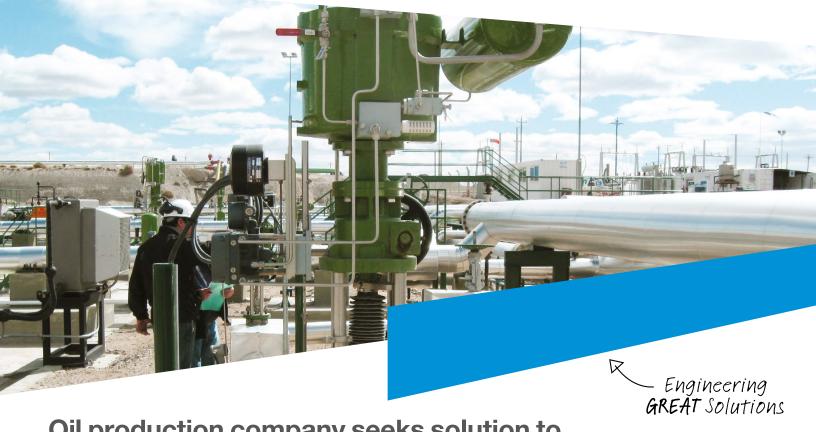
100D DRAG[®] valve

Unlike traditional control valves, the DRAG[®] multi-stage, multi-turn technology divides the pressure reduction into many smaller stages. The number of turns, or stages, is selected to ensure a specific fluid discharge velocity is achieved at the exit of the control element. By switching to IMI CCI's DRAG[®] technology, in this case the custom 100D DRAG[®] valve, the customer was able to increase controllability of their water injection stations, resulting in reduced maintenance needs and avoiding costly shutdowns.
